GOSHAWK

FLIER

VOL. 3 No. 2 ~ FALL 2011

Inside this Issue

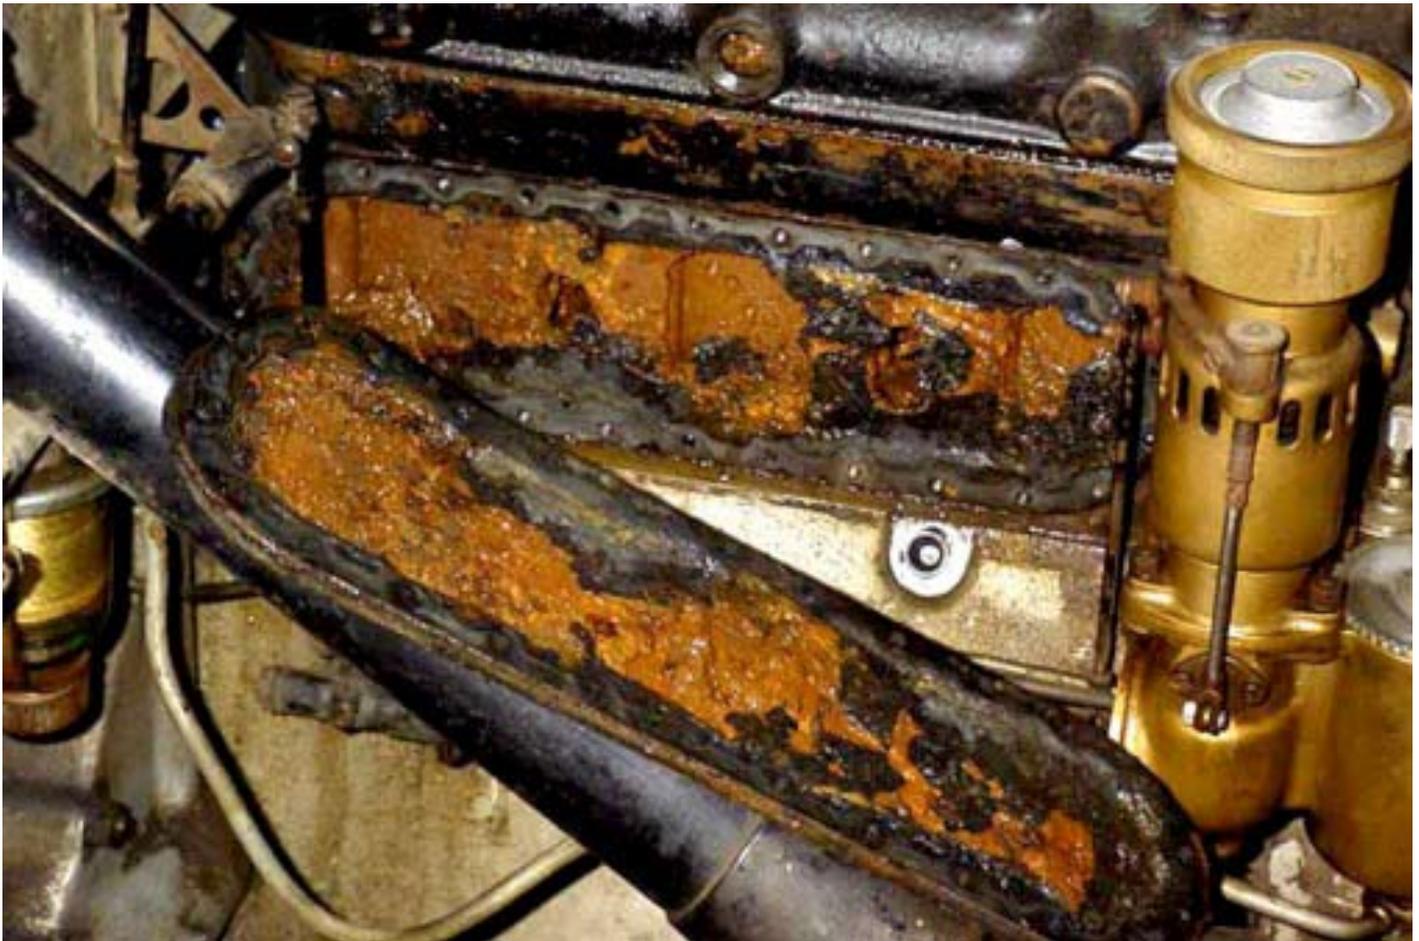
However, fast-forward to around year 2000. I am doing recommissioning and testing for what was to become an 8 year full time personal ground-up restoration. Alas, the previous water pump fix was not enough to prevent overheating in some situations (like idling over two minutes. after reaching operating temperature). Sooo, the engine needs more than just cosmetics, it has to come apart. Lucky that, as it turns out. Sure, I did find rusted deposits blocking both large and small cooling passages (see photo below), but there turns out to have been four more critical reasons requiring a rebuild.

But first, the water passages. Flushing with diluted muriatic acid (driveway cleaner), poking and prodding with every shape and form of blade, wire, and pick did the trick. One has to concentrate attention on the area in the middle of the block around where the fuel-air mixture from

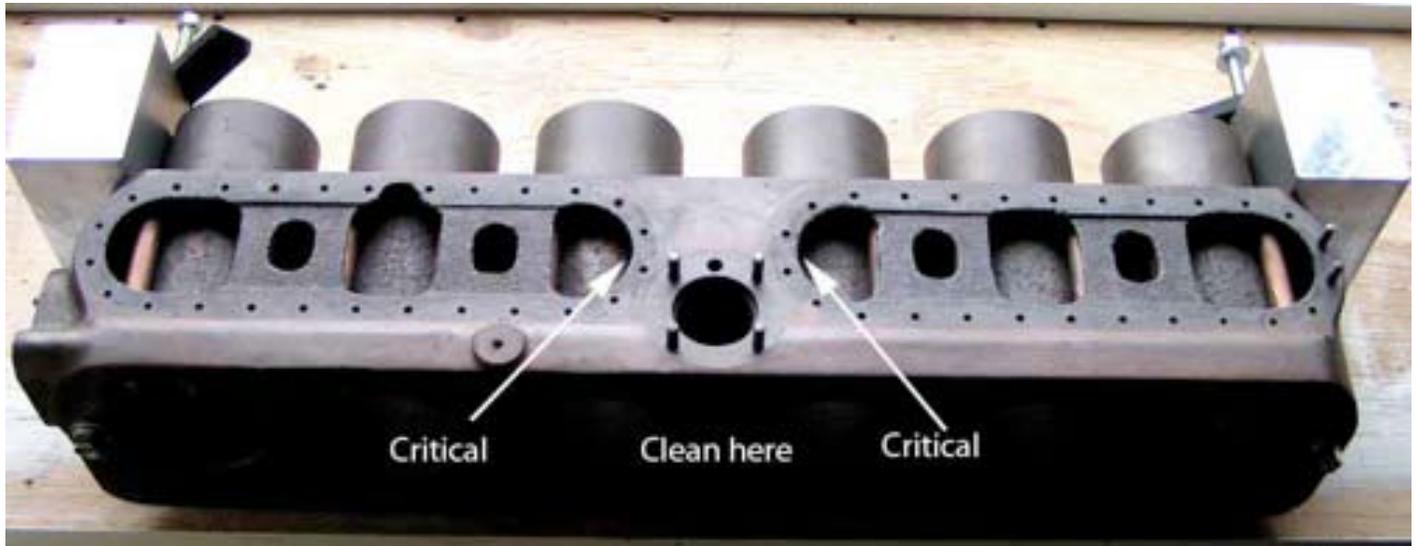
the carburetor passes through the block between the #3 and #4 cylinders, where the fuel-air mixture from the carburetor passes through on its way to the intake manifold. That is a restricted area that impedes water flow even when clean.

I had often read technical articles that suggested having the water pump input to the front and back water jacket covers because of this restricting design. That fix always seemed to come with a plumbing nightmare that never looked "Rolls-Royce". Then I found reference to a technical bulletin around 1930 that called for holes in the front of the head to be blocked to prevent coolant from entering the front of the

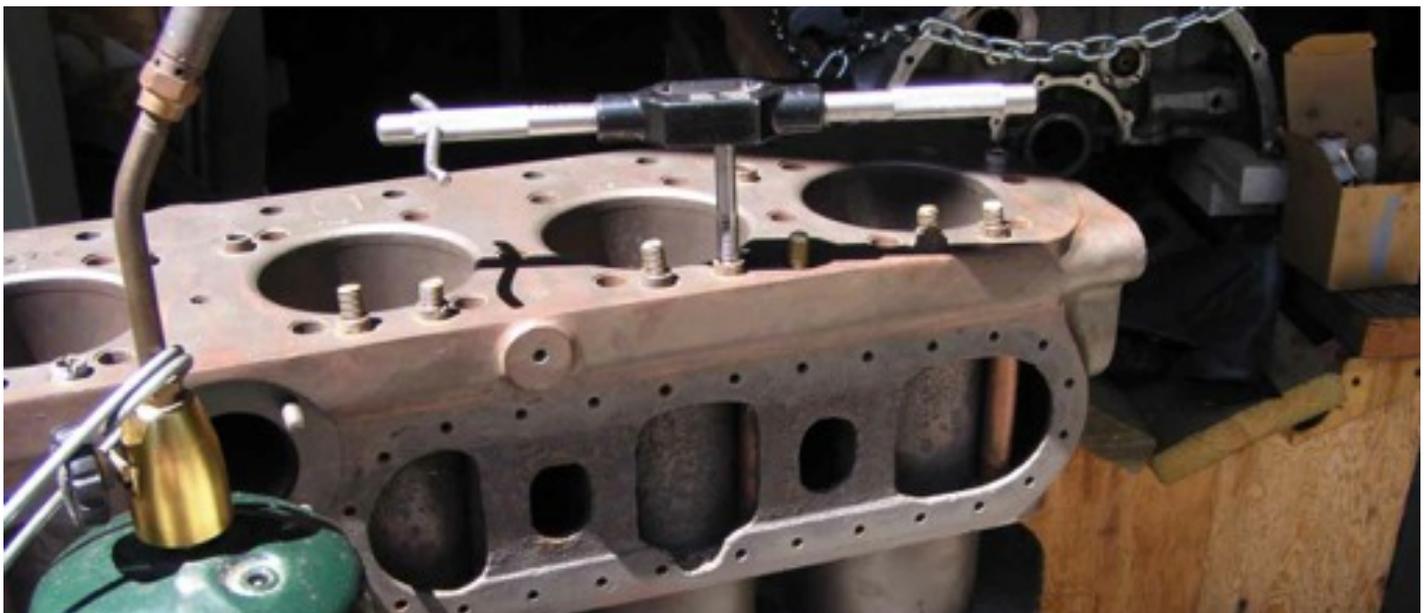
block and then promptly going straight up into the head and returning to the radiator without cooling the rear of the engine. (taking the least path of resistance and avoiding the restriction) So I made the mod by drilling and tapping the brass fittings in the block that acted as guide pins mating with the head. Then I screwed in brass plugs and soldered them in place

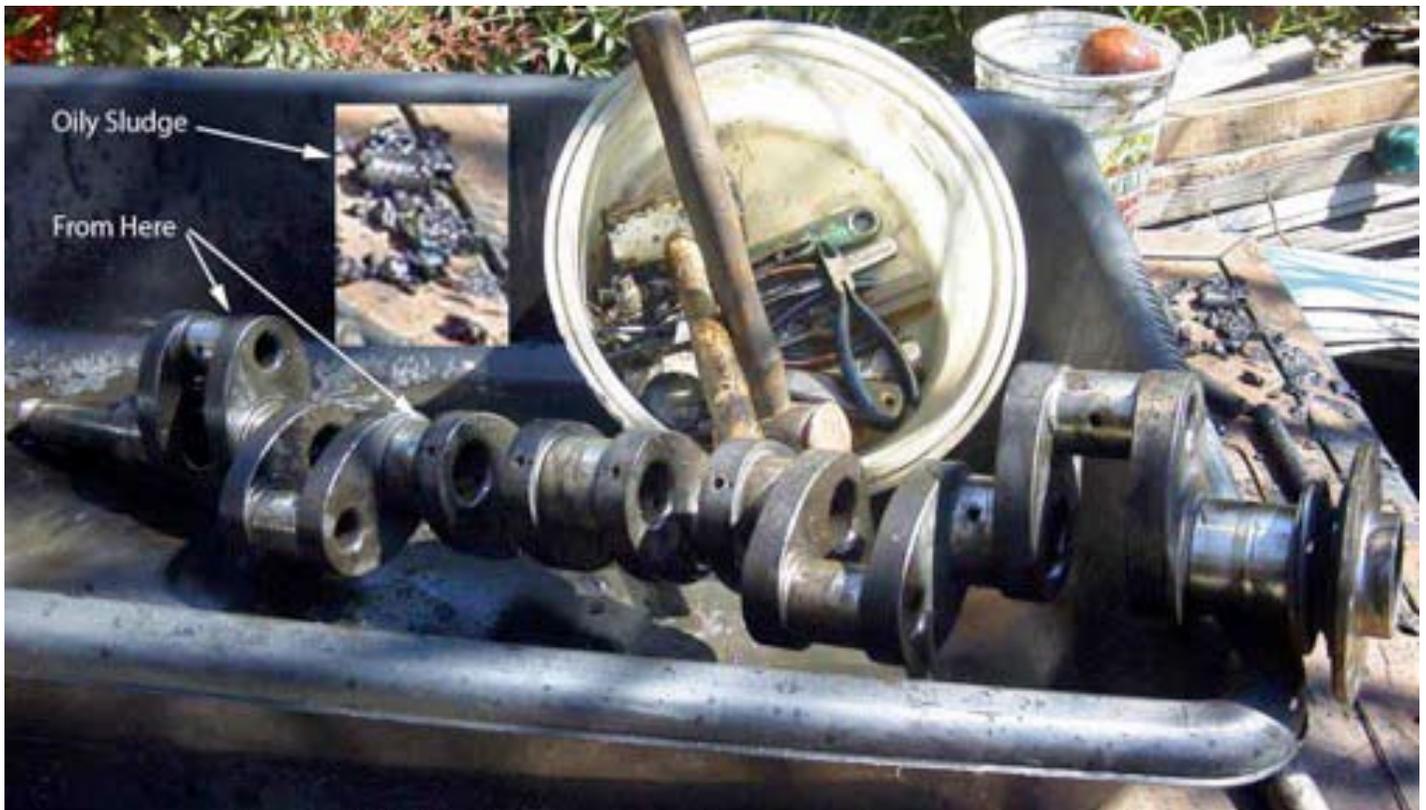
Periodically, the pan was dropped, crankshaft gallery plugs pulled, and everything was then flushed. What happened was that the spinning crankshaft centrifuged out the sludge particles in the oil and deposited them in the galleries as solid sludge. In my case the sludge was so compacted that it took a wooden dowel turned to the correct diameter and a mallet so as to drive out the sandy, tar-like substance.

That takes care of one potential hazard to the rod and main bearings. You need to test that the gallery plugs don't leak and also take care to observe that the oil pipes in the crankcase webbing that deliver oil to the crankshaft are not leaking (mine were). One should also check the connecting rod oil pipes that go up to the wrist pins.

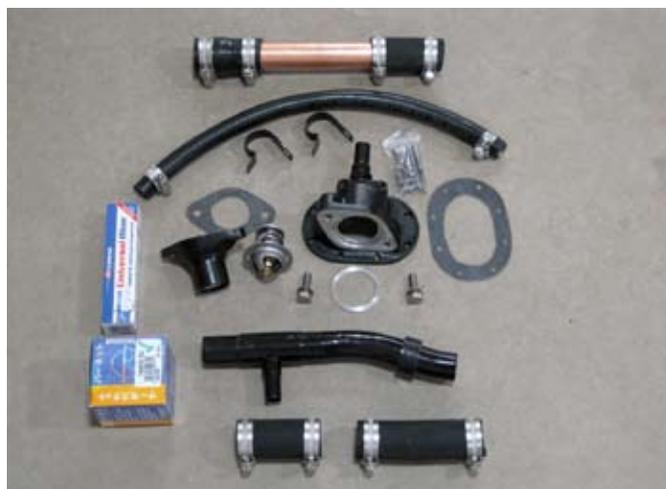
Top to bottom: top hose; bypass hose and clips; thermostat and housing; bottom hoses with 'T' connection.

A recent product is the Valstat developed by Vintage Accessories Ltd in the UK. This neat casting replaces the front outlet pipe on the cylinder head with a two-piece casting that contains a modern thermostat. A bypass hose allows coolant circulation within the engine during warm up and is then closed off as the thermostat opens to allow the feed into the radiator header tank. The Calorstat can be left connected and normally adjusted, the shutters acting in the usual manner at all temperatures. The advantage is rapid engine heating combined with controlled and constant engine temperature under all driving conditions, which ensures efficient petrol usage as well as prolonged engine life as the oil is running at its design specification. GGA27 was used to test the prototype of this accessory along with 7 other UK owners of 20HP, 20/25 and 25/30 cars. Other than being thoroughly satisfied with the results the author has no connection with the manufacturer but can recommend this product as a worthwhile amendment for all SHP owners.

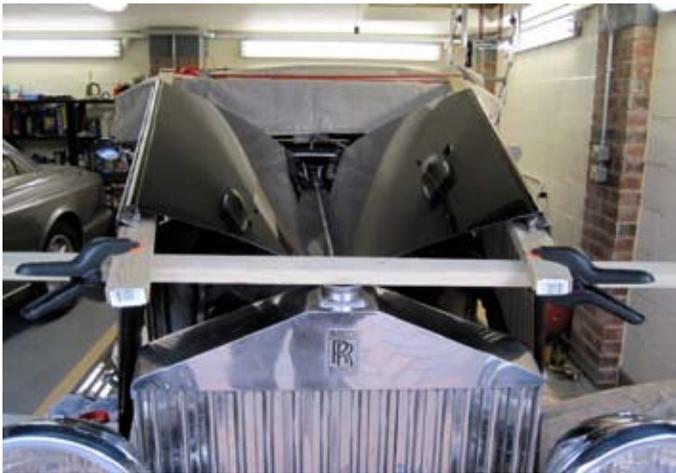
Bonnet resting securely on timber frame and ready to be lifted up and out of the way.

The first job is to remove the bonnet. Remove the saddle from the front of the centre hinge and the nut from the rear hinge bracket. Place a thick cloth onto the roof above the windscreen and another over the top of the radiator. Partially lift one side of the bonnet and slide a length of 2"x1" timber along the hinge line, from the front, onto the roof and rest the other end on the covered radiator. Repeat on the other side of the bonnet. Use string or a luggage strap around the rear ends of the two timbers to prevent them slipping outwards. Attach a third piece of timber between the front ends of the other two and fix in place with clamps. Another strap around the cross-timber can be used to lift the bonnet up and away from the radiator – attach to a secure overhead support or skyhook..

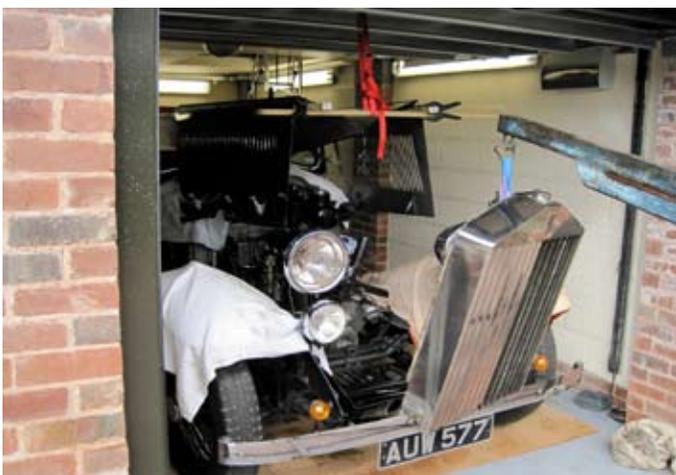
An engine hoist is probably the safest method for removing the radiator.

Drain off the coolant, remove the top and bottom hoses and release the front of the radiator steady rod. On later 20/25 chassis it will be necessary to remove the drain tap from the lower, driver's side of the radiator. Remove the split pins, nuts, washers and springs from the two locating studs in the base of the radiator. Take care to remove the two brass trunnions *and note which side they fit*. One trunnion is hemispherical and the other barrel shaped – each fitting into an appropriately shaped socket on the base of the radiator. Make sure they are replaced on the correct side and in the proper orientation to the sockets. Lift out the radiator, taking care not to damage the lights or paintwork. It should take only about 30 minutes to reach this point.

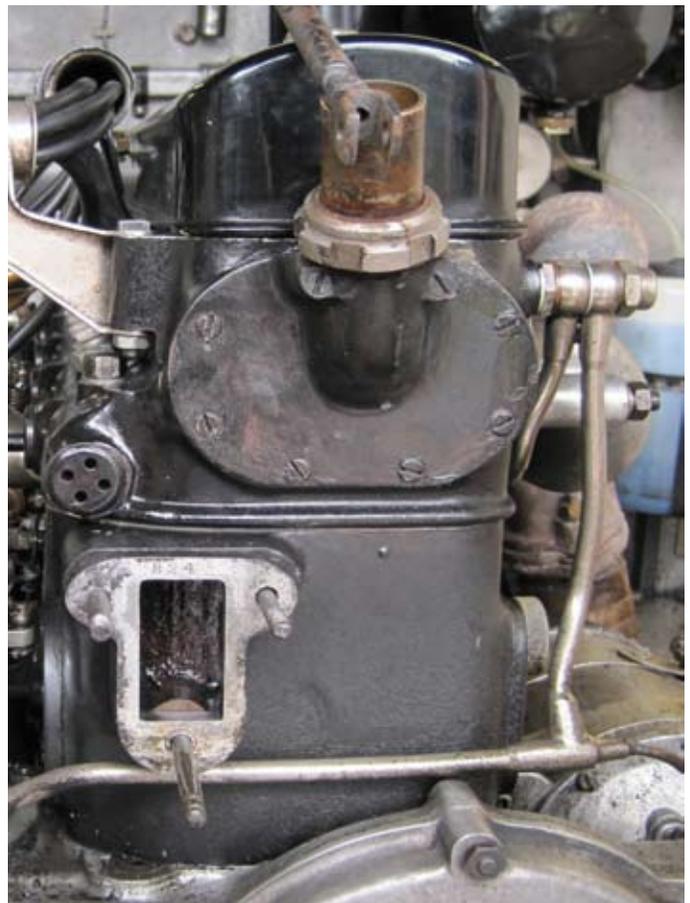
Fan removed to reveal the front end plate and water outlet pipe.

The next operation is where some delay might be encountered. Remove the 6 short and 2 long machine screws that secure the end plate to the front of the cylinder head. It is probable that the inner threaded ends will have corroded and bonded to the cylinder head. The only option is to carefully drill out the recalcitrant fasteners.

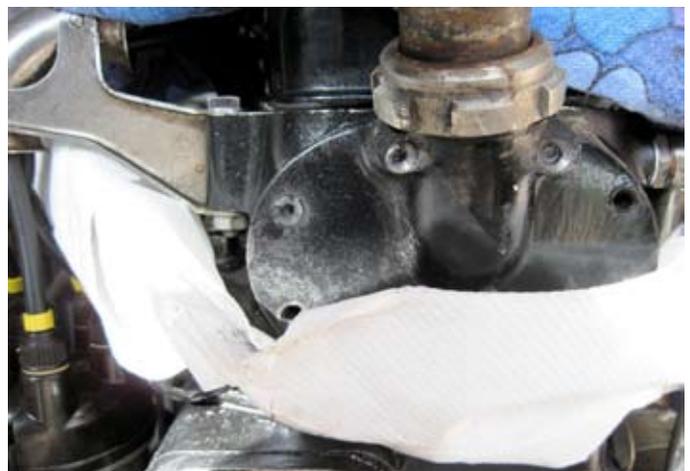
Seized machine screws drilled out. The white paper shroud under the plate is to catch the swarf.

Clean out the threads in the cylinder head and clean off the mating surface. Make sure that there are replacement 2BA machine screws in stock to replace any that have been damaged during removal. Apply gasket and thread sealant to the mating faces and fasteners and attach the base of the Valstat to the cylinder head. Inset the thermostat, sealing ring, gasket upper casting and bolt everything together. Install the bypass hose and the two clips that fix it to the timing case studs: ensure that the bypass hose is clear of the fan belt.

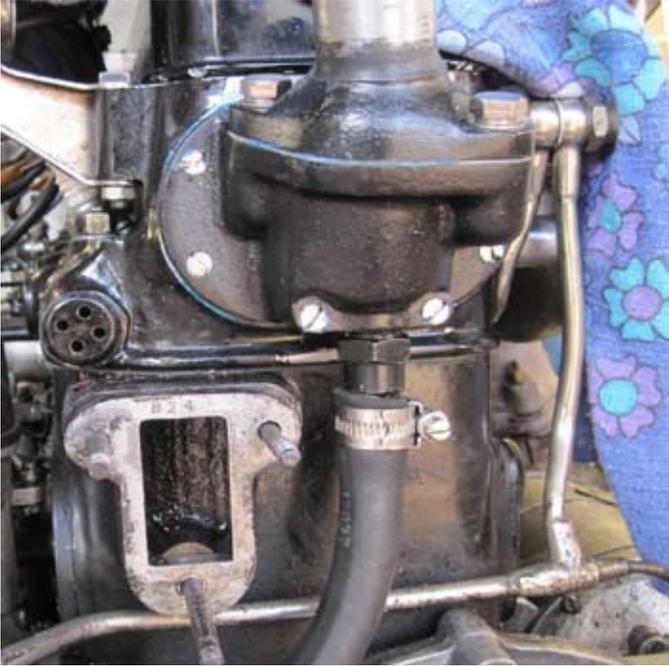
Valstat in place and bypass hose connected.

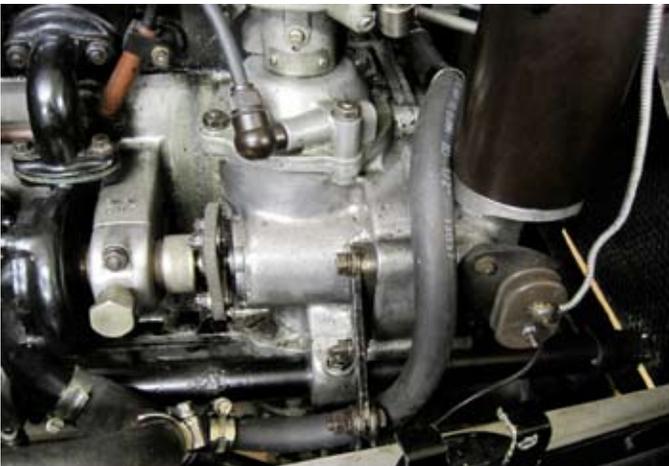
Bypass hose routed around the front of the engine and away from moving parts.

Install the new top and bottom hoses and connect the other end of the bypass hose to the new 'T' connection in the bottom tube. Replace the radiator, making sure that the brass trunnions are in the right place. Refit the radiator tap if previously
